A Technical Analysis of John Knox's *Regatta* c. 1825-30

Alexandra Earl

MLitt Technical Art History

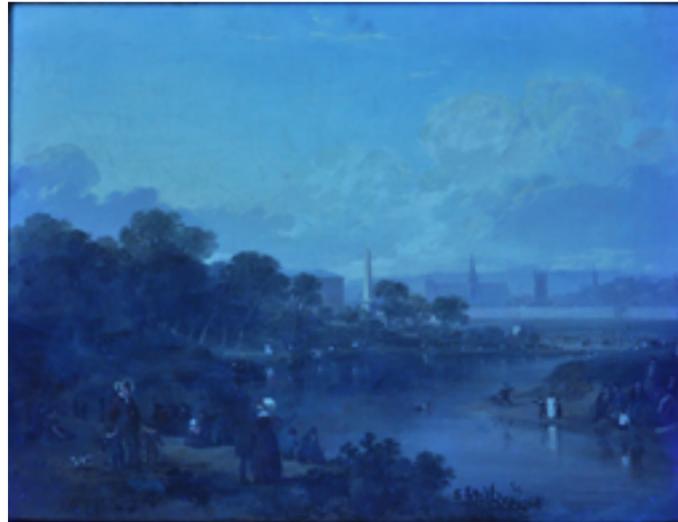
An ultraviolet photograph of *Regatta* showing the greenish-blue fluorescence of a natural resin varnish

Ultraviolet light revealed the presence of a natural resin varnish applied evenly over the paint surface. Upon first impression, the greenish-blue fluorescence (indicating an aged varnish) suggested that the surface coating could be original. Although, the fact that this painting has been relined implies that the varnish was likely applied after a past conservation treatment. A label on the reverse dated 'February 1983' may be an indicator of when this treatment took place.

A strip of darkened varnish, which extends around the edges of the painting, highlights that the artwork was previously cleaned whilst in its frame. In the reflected ultraviolet image, no evidence of retouching was detected. Moreover, areas of strong fluorescence show that the artist applied white pigment to highlight elements of the figures' clothing.

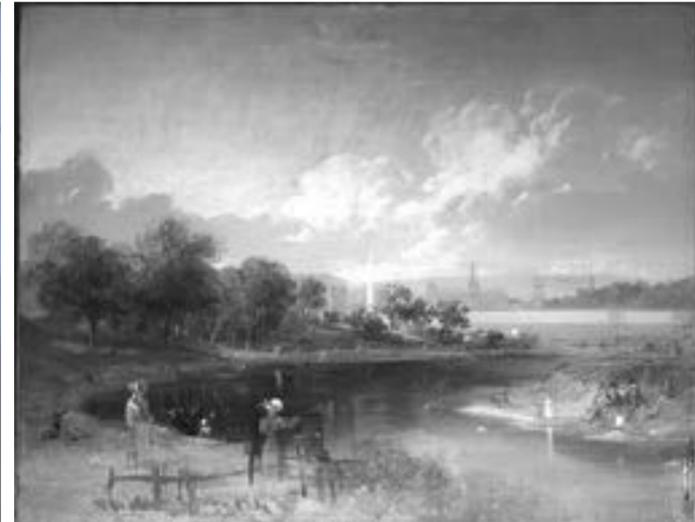
An infrared photograph of *Regatta* showing the artist's underdrawings and underpainting

An Apollo infrared camera system (0.9–1.7µm) was used to expose the artist's original underdrawings, which had initially been detected under magnification.

The infrared photograph shows that the architecture, trees and riverbank were all roughly sketched using a carbon-based material. Contrastingly, the clouds and figures were painted freehand – suggesting that they were possibly painted from life or derived from preparatory drawings. Another key result obtained through infrared reflectography is evidence of pentimenti. The presence of trees on the right, which do not appear in the final painting, demonstrate how the artist removed elements of the composition during the painting process. Similarly, an underpainting of a pontoon or bridge-like structure in the foreground was overpainted as it does not feature in the finished scene.
